— School Bus Flyer —

Allison 1000 and 2000 Transmission Fluid Loss from Main Housing Breather During Cold Weather Operation

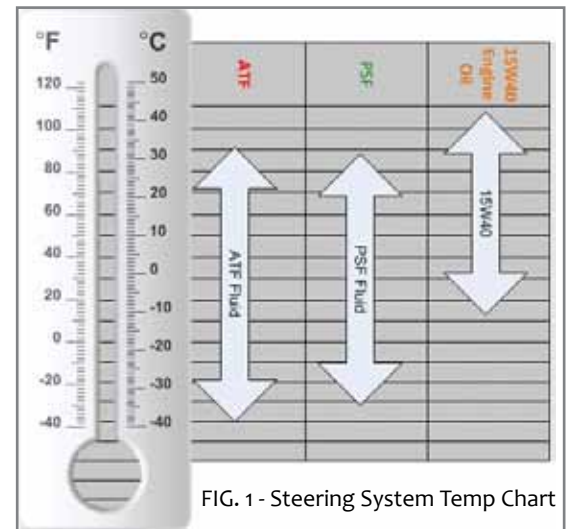
All vehicles manufactured in 2017 will be factory filled with ATF fluid. This will be easily identified by red colored fluid in the steering reservoir. The new ATF fluid is backwards compatible with earlier built vehicles. Please note that every time steering fluid will be swapped a complete steering system flush is required. For ease of service there are two other applicable fluids that can be used referenced in the parts section of this iKnow. It is recommended to use the chart below to determine what fluid best fits the application of the users fleet or vehicle.

Caution: ATF and PSF are the ONLY acceptable fluids for vehicles equipped with brake booster hydraulic systems.
